## Midland 445 BT

### Factory modifications:

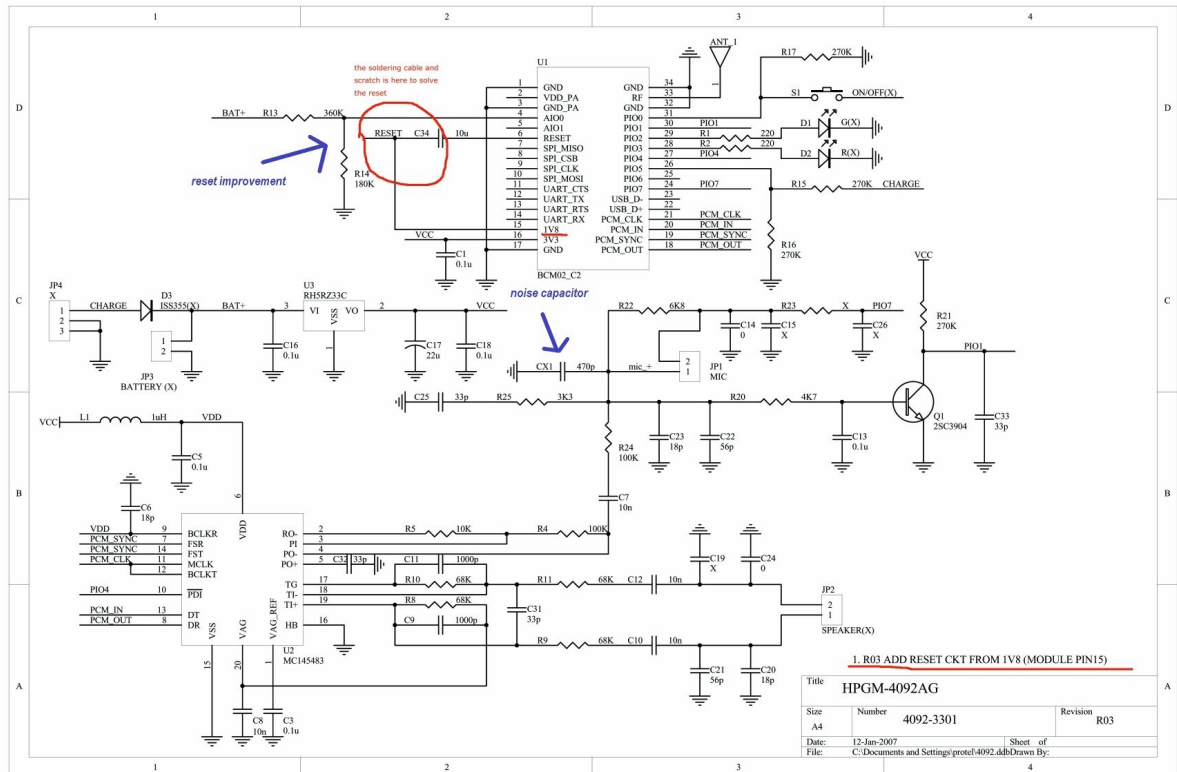
**Drawing 1**

2. **The TX modulation in of the 445 BT in Bluetooth mode still produces some multiplexer noise in the background.**

To improve this problem, we delete R 22 (6.8 kOhm) from the Bluetooth Sub Board and insert 470 pF at the same position on the Bluetooth Board.

(see drawing 1 and drawing 2)

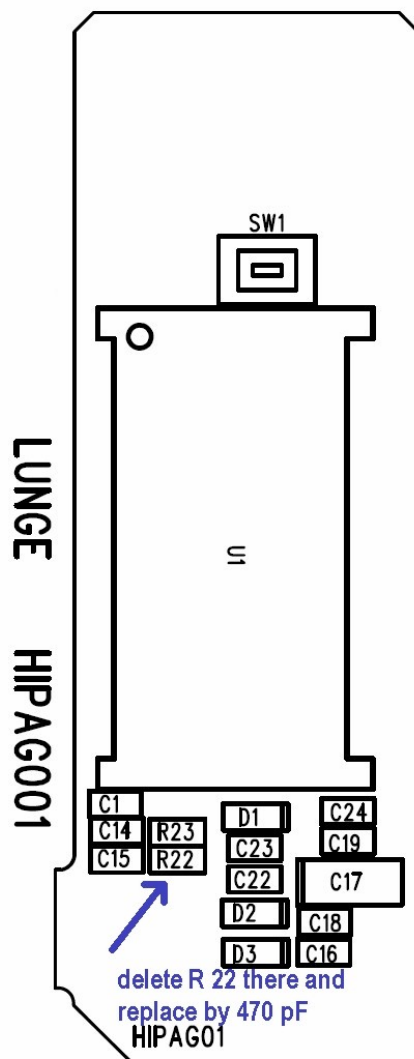
**Drawing 2:** Deleting 22 k and adding 470 pF on Bluetooth Board

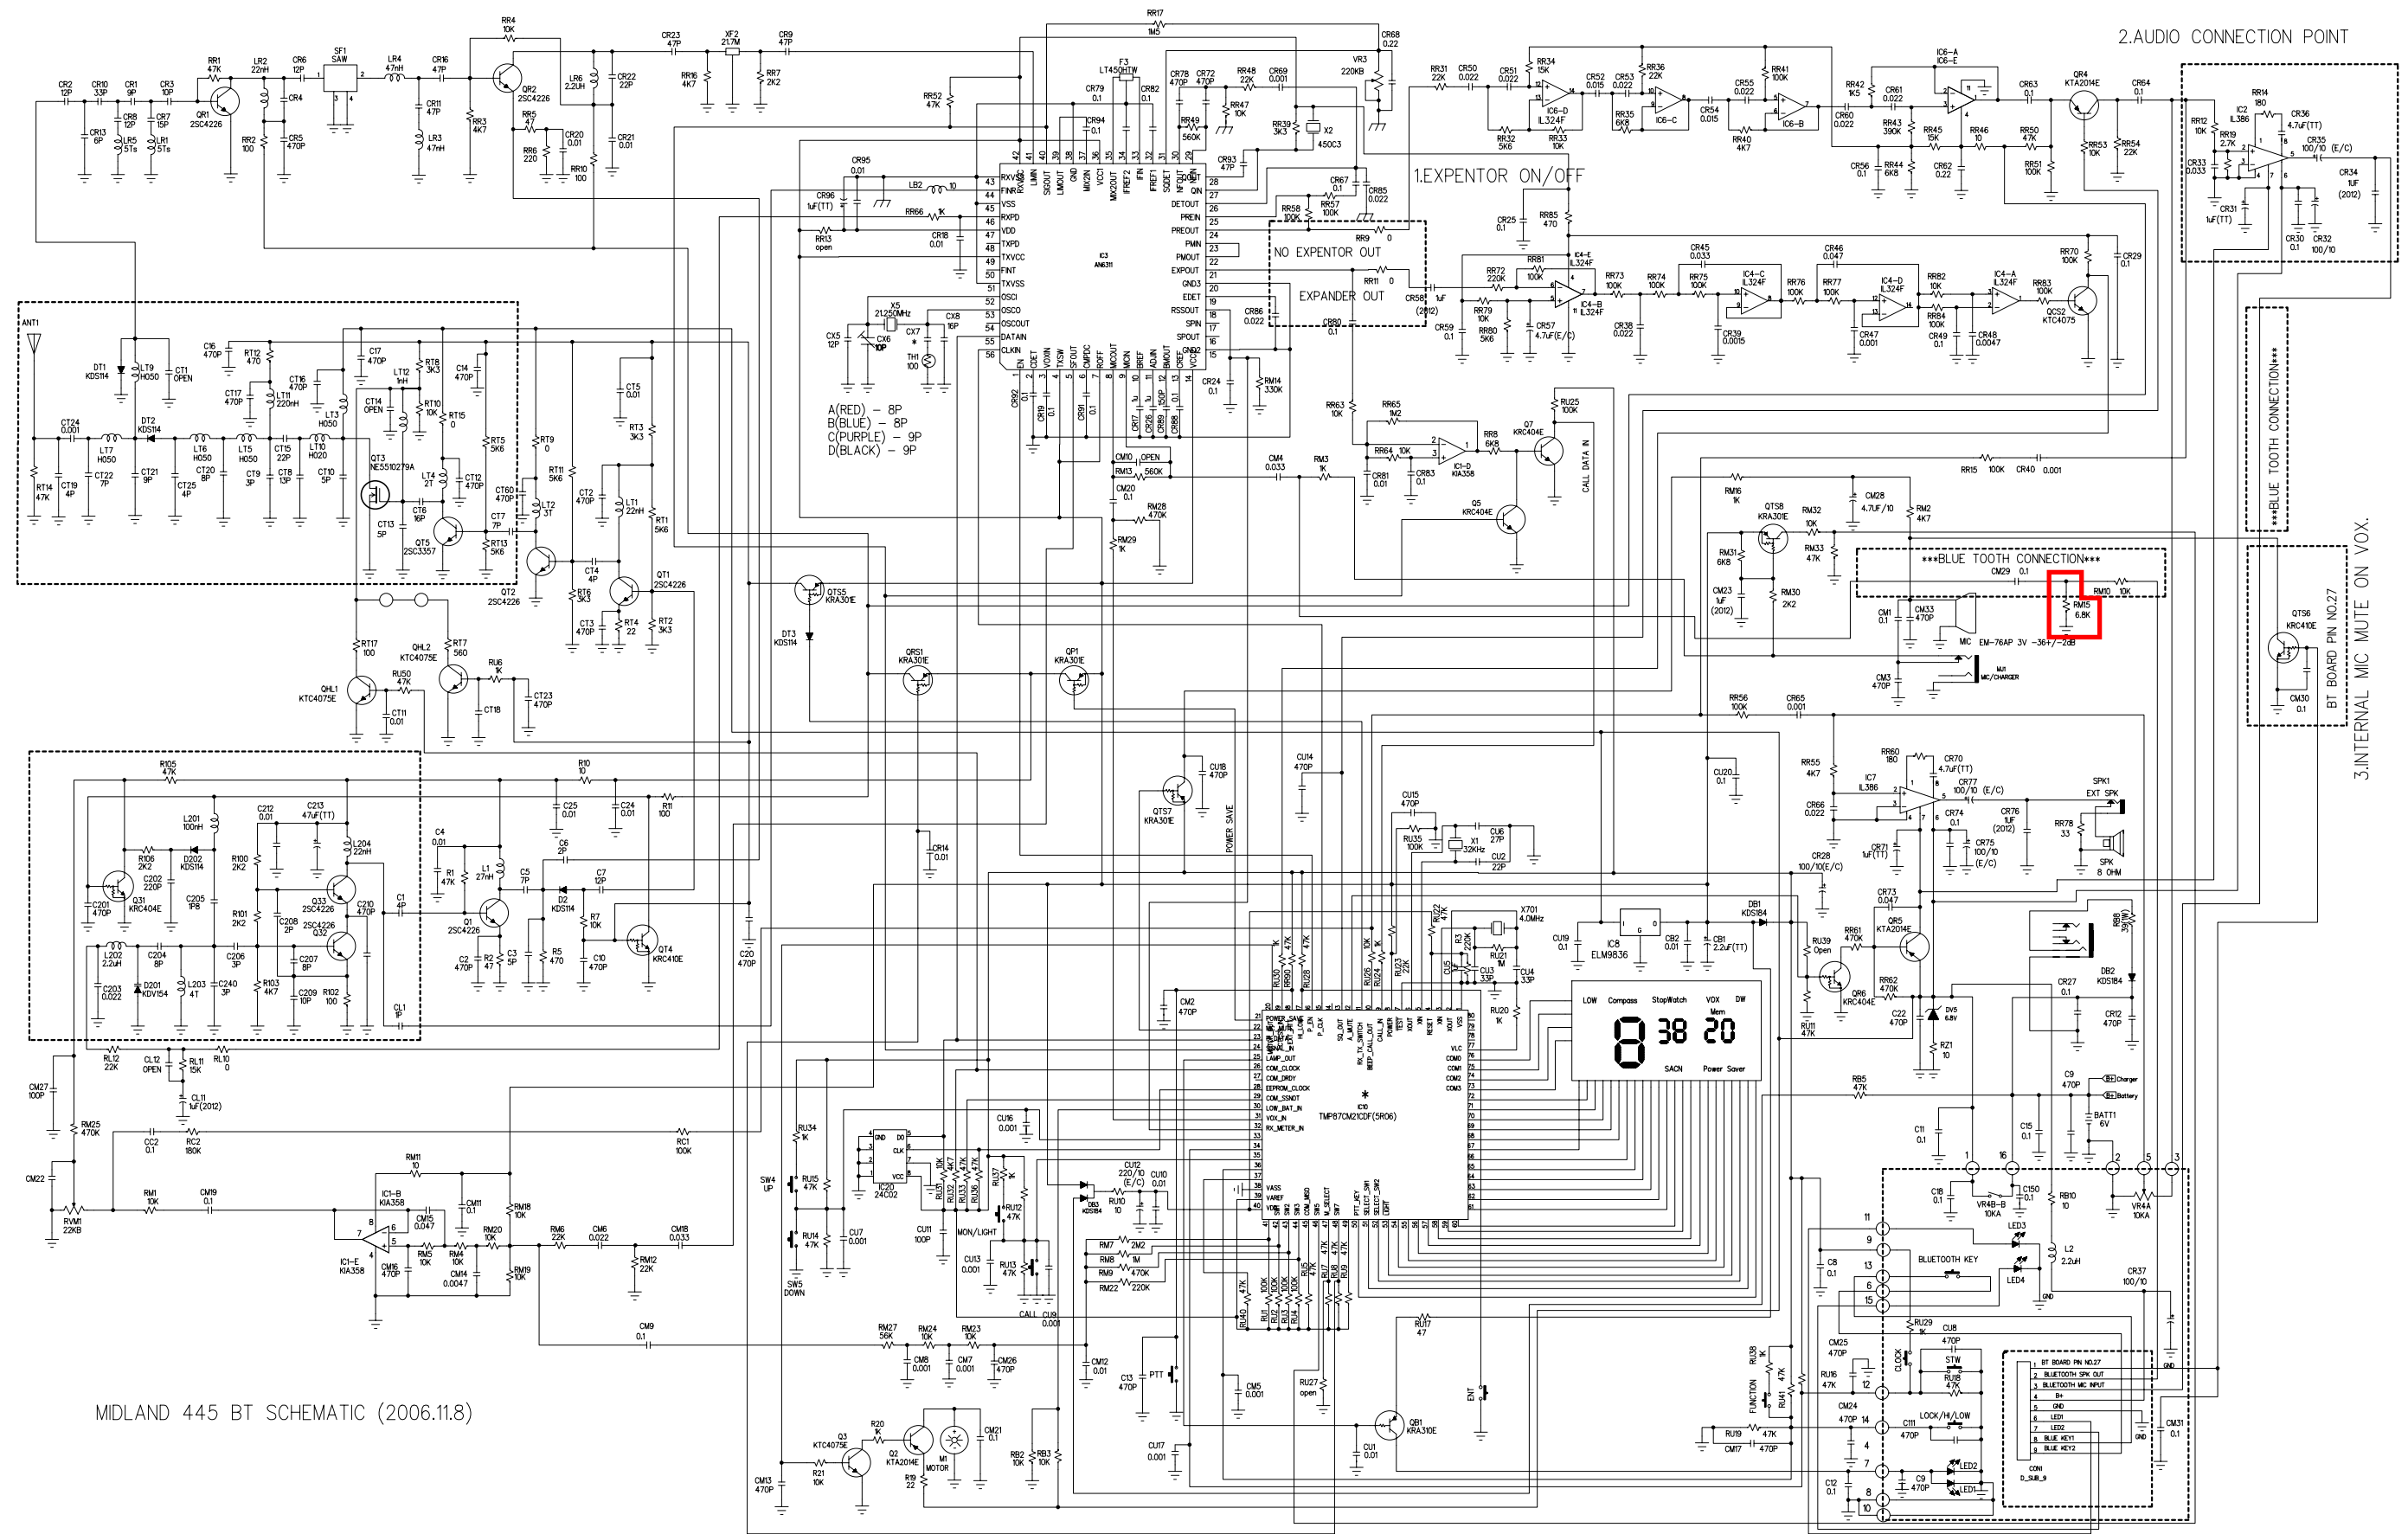
Please see the attached circuit diagram which shows the modification on RM 15 position in 445 BT radio main board.

We insert the deleted R 22 (6.8 kOhm) on the main board of 445 BT at the RM 15 position. (see attached circuit diagram,)
