## Service Mitteilung

AE 4200 MC - 1. Oktober 2007

Seriennummern startend mit 065....

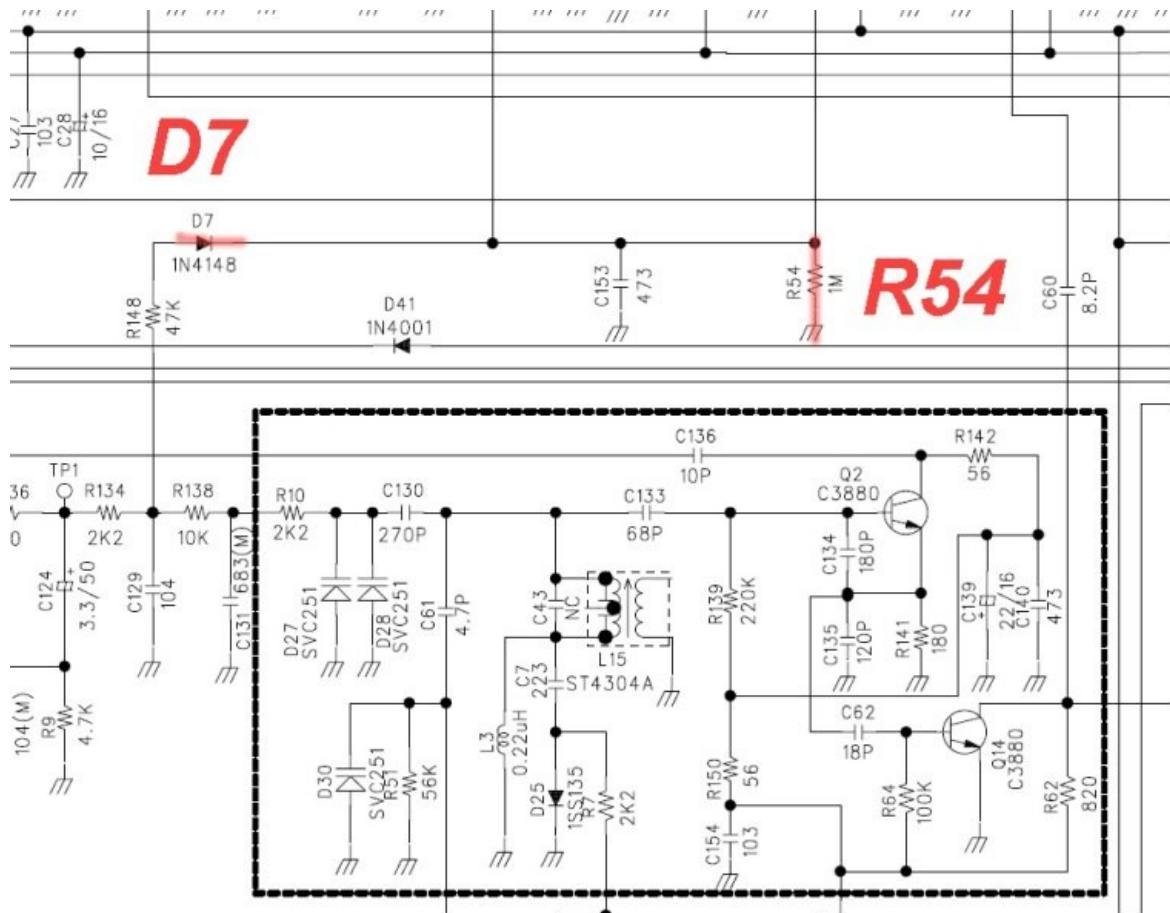
**Problem:** Es dauert nach dem Loslassen der PTT Taste ein paar Sekunden, bis der Empfänger mit voller Lautstärke (AM) bzw. voller Empfindlichkeit (FM) arbeitet. Während dieser Zeit wird der Empfang kontinuierlich besser bzw. lauter.

**Ursache:** Bei neueren Geräten ist Diode D 7 (zwischen VCO Käfig und Frontseite) eingebaut, ältere Geräte, die nicht betroffen sind, haben dort eine Drahtbrücke anstelle der Diode.

**In Geräten mit Diode D 7 muss auch R 54 angeschlossen sein.**

Leider wurde diese Verbindung bei einigen Geräten versehentlich nicht eingelötet. Wegen der Diode D 7 kann sich bei Empfang die (höhere TX-) Abstimmspannung der Kapazitätsdioden nur über Leckströme entladen, was je nach Gerät zwischen 1 und 10 Sekunden dauern kann. Während dieser Zeit sind die Vorkreise noch verstimmt, daher ist das Gerät für einen Moment noch unempfindlich.

Die fehlende Verbindung auf Platinenunterseite mit einem SMD Widerstand oder einer Drahtbrücke überbrücken. Wir empfehlen einen hochohmigen Widerstand, z.B. 2.2 MOHM, weil dabei kein Nachgleich erforderlich ist. Bei niederohmigen Verbindungen (z.B. Drahtbrücke) ist Nachgleich der Empfänger-Vorkreise erforderlich.

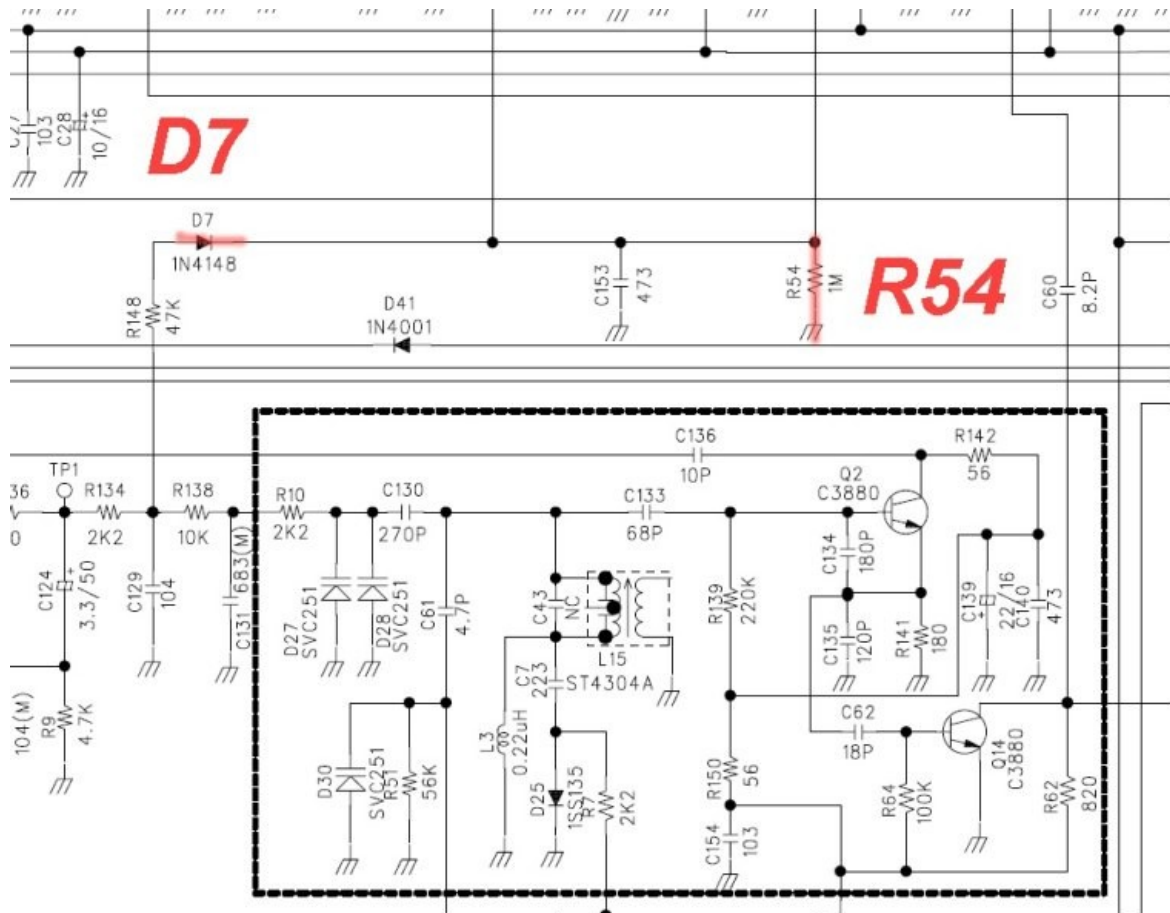
**Problem:** It may need some seconds after releasing the PTT knob, until the receiver will have it's optimum sensitivity.

**Reason:** in new AE 4200 MC versions, diode D 7 is inserted (located between VCO shielding and front side). Older units, which do not show the problem , have a jumper instead of D 7.

**Radios with D 7 inserted must also have a connected R 54 resistor.**

Unfortunately in some cases the connection of R 54 had been forgotten to solder in recent production. This will cause that the higher DC voltage level for the tuning diodes (during TX mode) will not discharge fast enough when switching from TX to RX. Depending on radio and PLL adjustment, this process can take between 1 and 10 seconds. During this time period the RX preselection filters may still be de-tuned.

Please add the missing connection on the soldering side by jumper or SMD resistor. If possible, take a high resistor value around 2.2 MOhm, because in that case you will not need any new filter alignment. If you take a jumper, a new tuning of the receiver filters may be necessary.
